***EVOLUTION***  
***Of the Mark II Button Hole***  
***Suffix***

Michael Mowbray FRCS

Orthopaedic Department

Mayday University Hospital

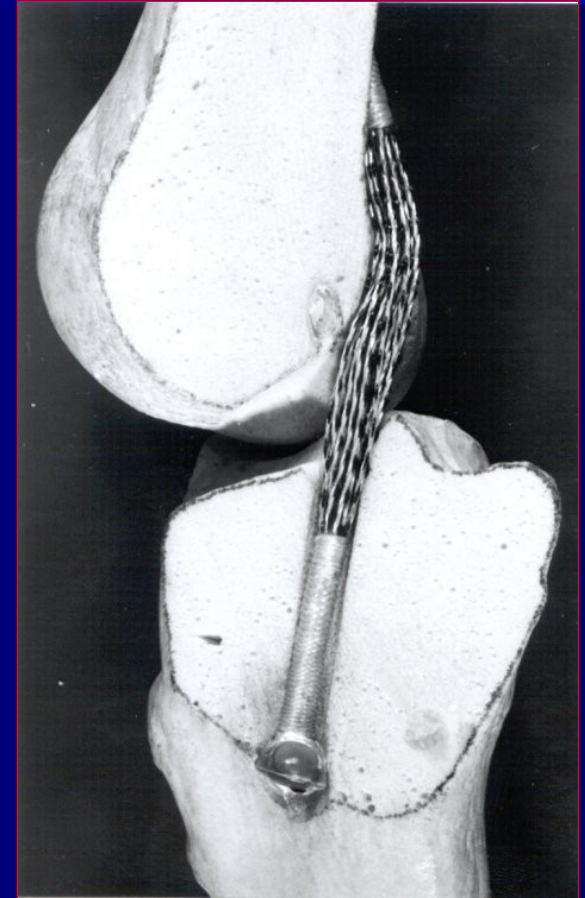
- The ABC is a scaffold-class prosthetic implant.
- It is routed via a tibial tunnel and fixed proximally over the top.
- It should lie retrosynovially in the knee joint.

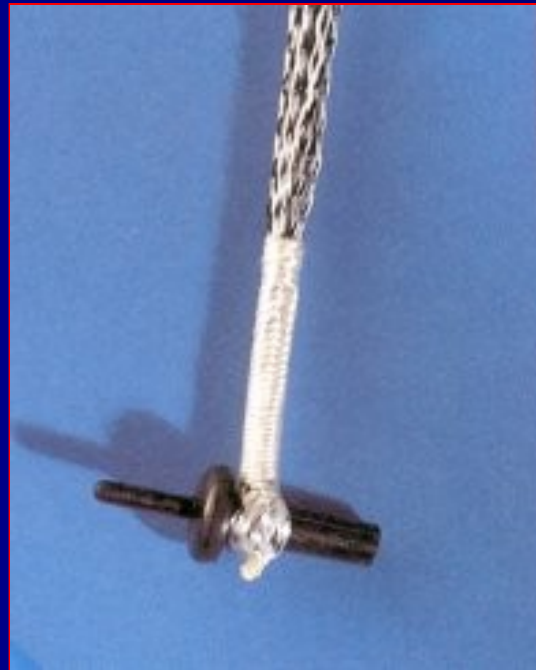
Double polysulphone bollards placed through loops at either end of the implant are used for proximal and distal unicortical fixation.

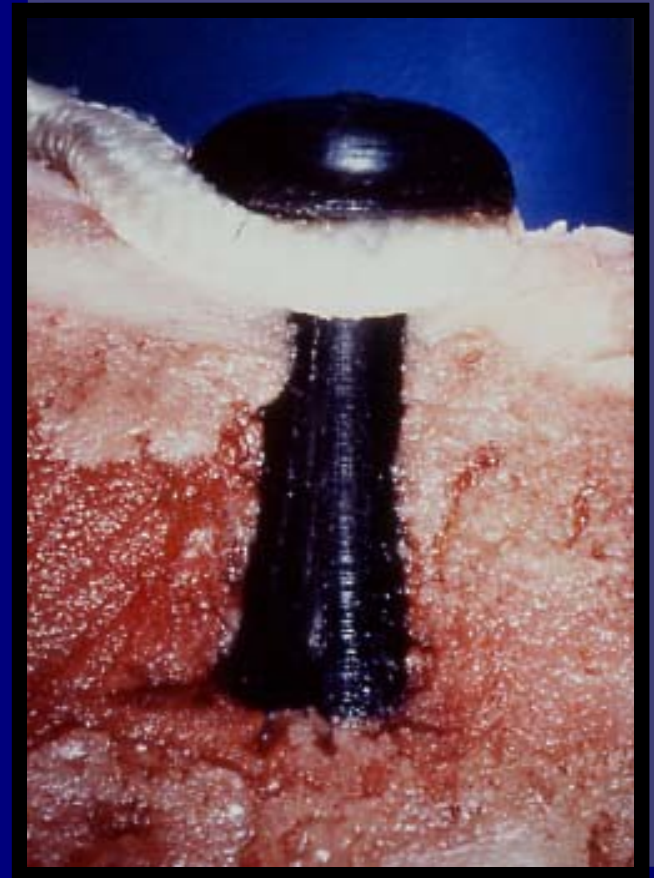
Expanded Bollard in Tunnel

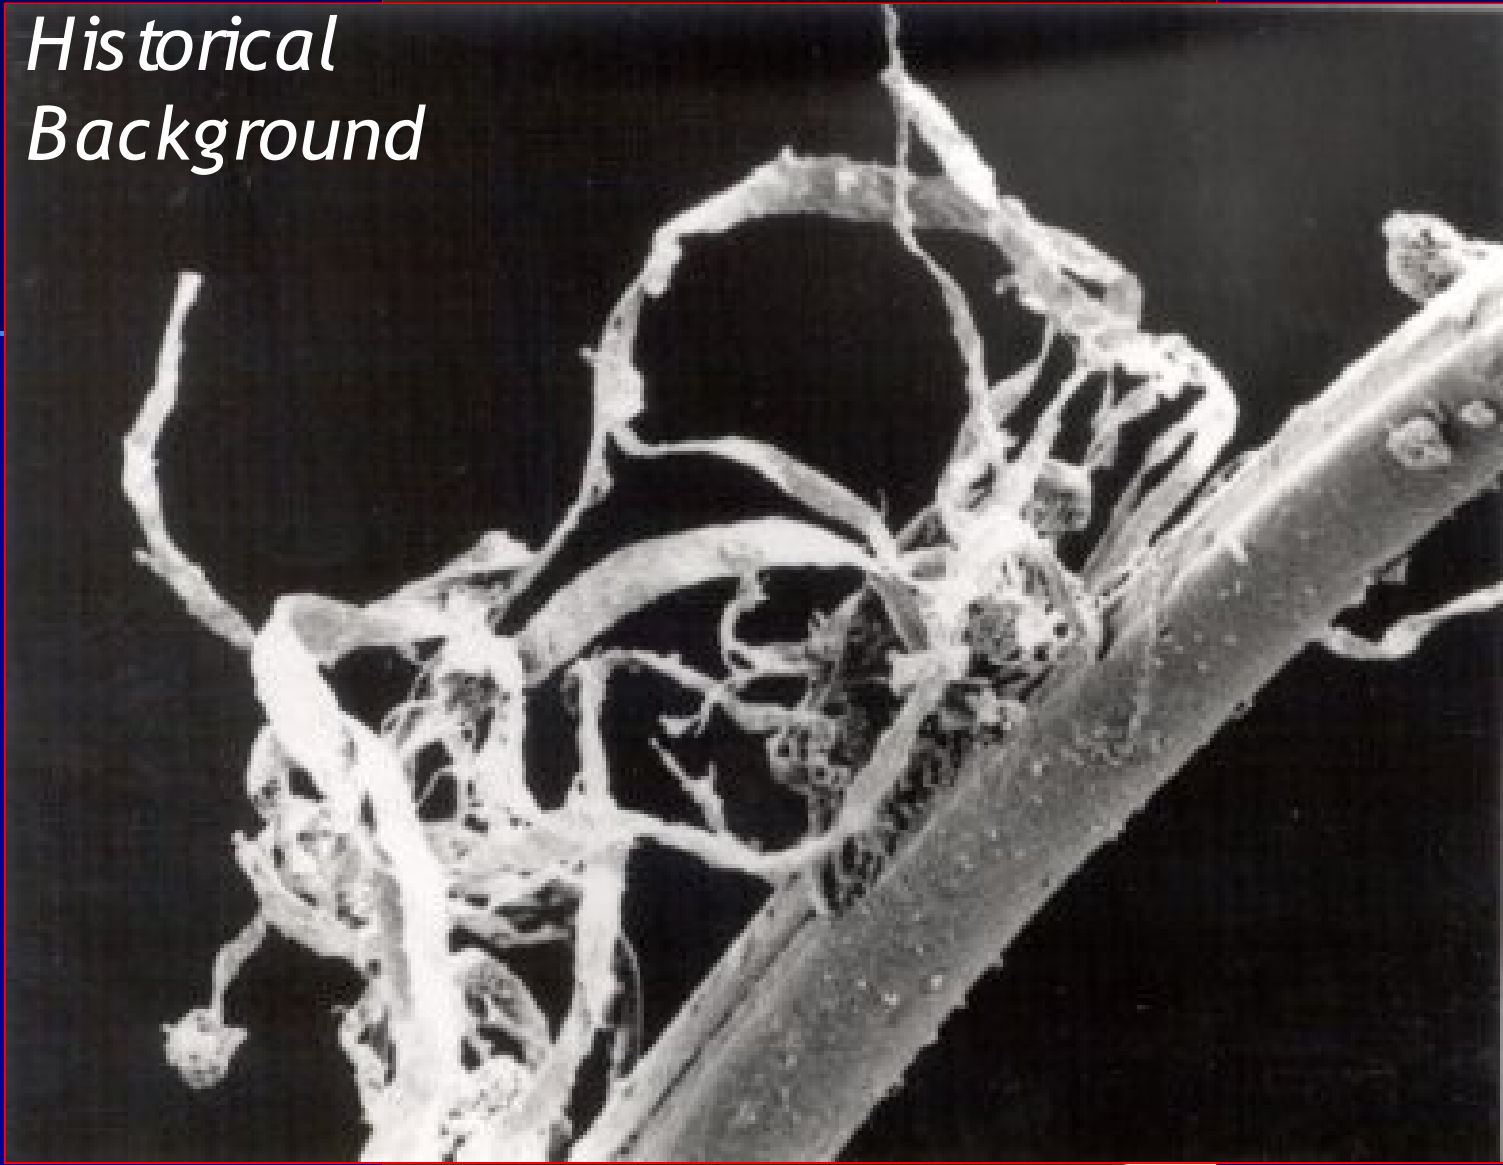
**LATE** (> 2 years) : due to mixture of mechanical failure,  
fretting & fatigue

SEM views of late ligament failure

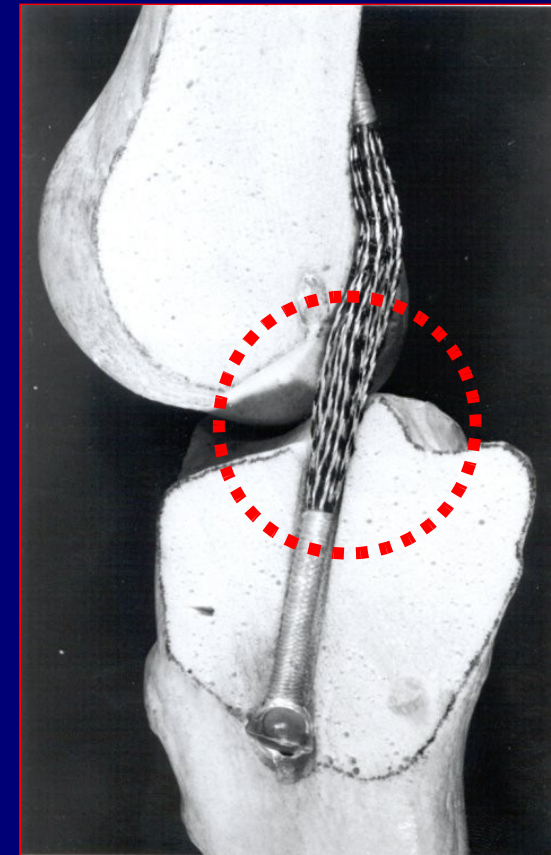
1. All ligaments failed at tibial tunnel exit.

1. Ligaments examined at the OTT route

showed no signs of fretting or fatigue.

1. There was no bollard fixation failure.

- The cause of early failure was mechanical impingement at the tibial tunnel exit.
- The cause of late failure was a mixture of both mechanical impingement and fatigue occurring again at the same site.

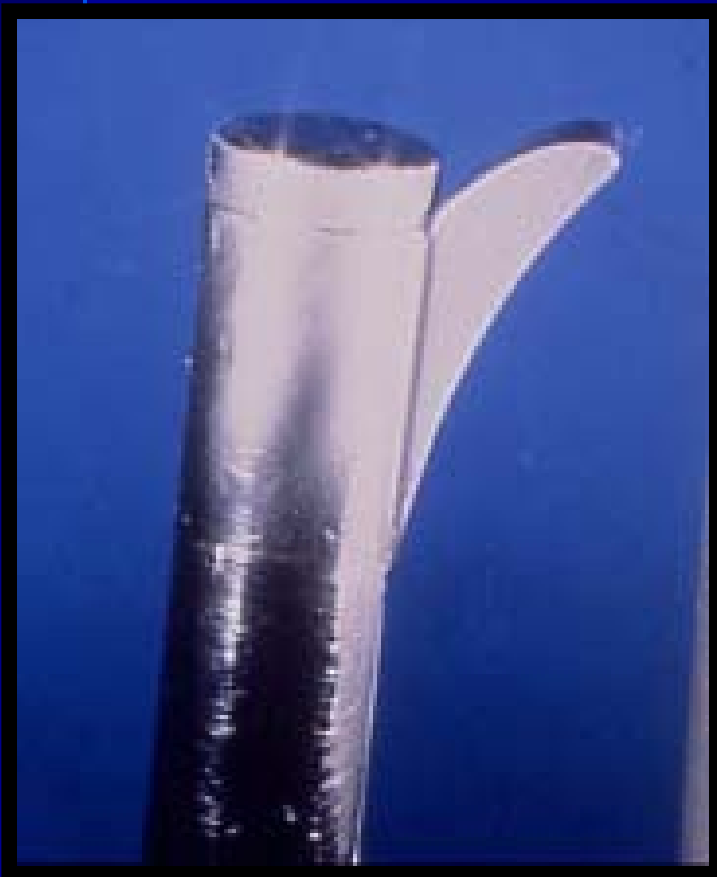
Back Radius Cutter

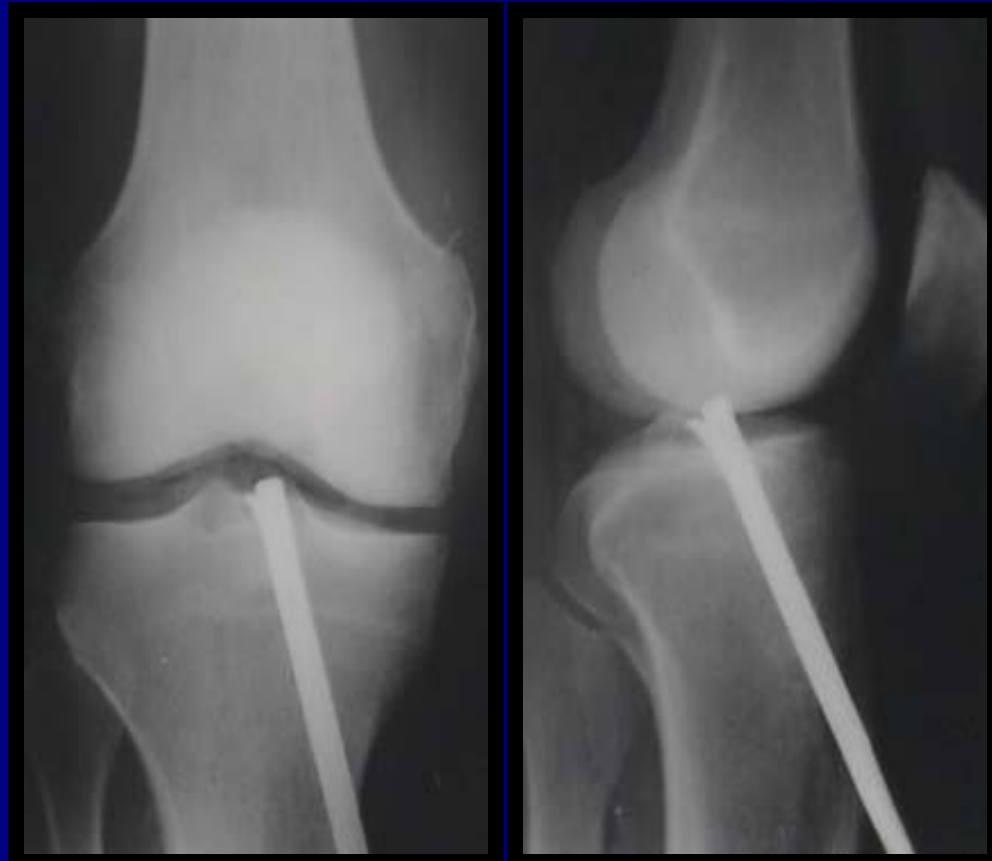
Position on AP & Lateral X-ray

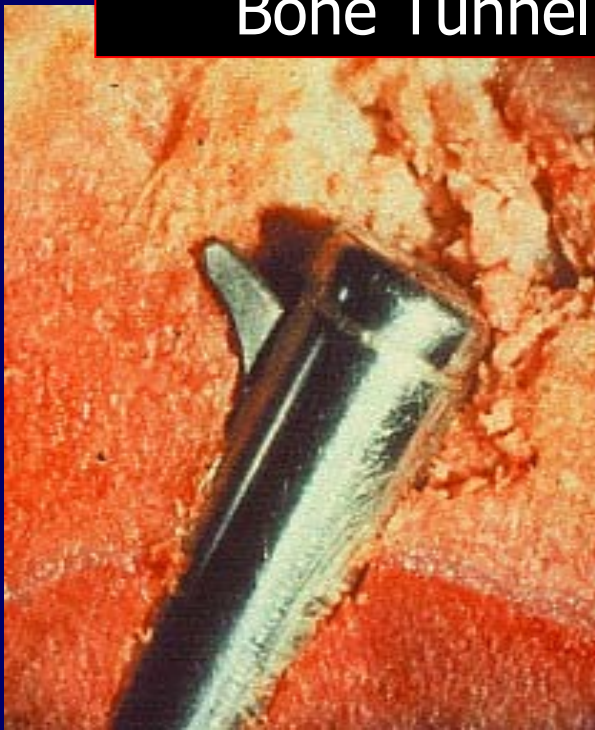
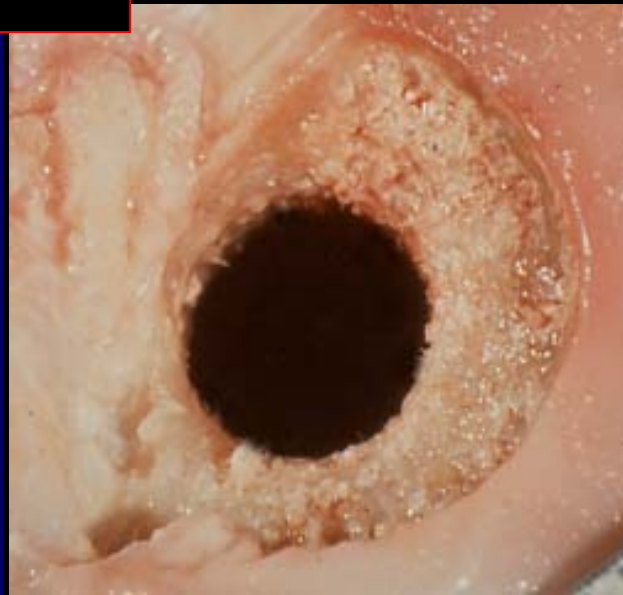
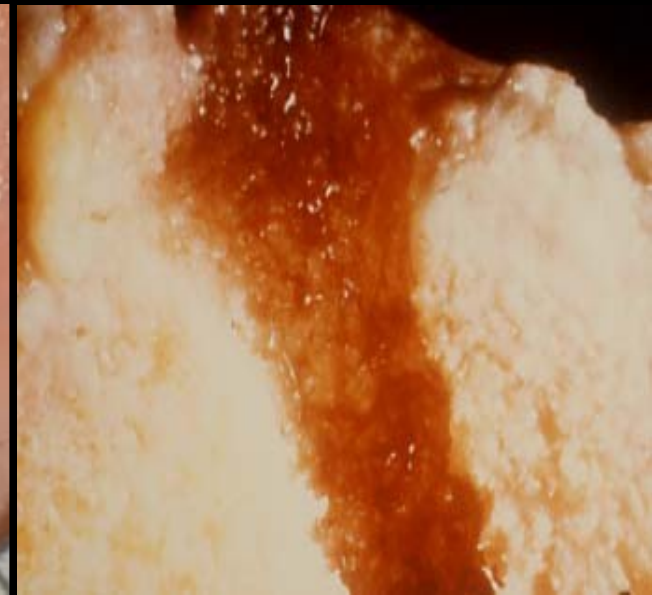
Back Radius Cutter  
in  
Bone Tunnel

Chamfered tunnel outlets

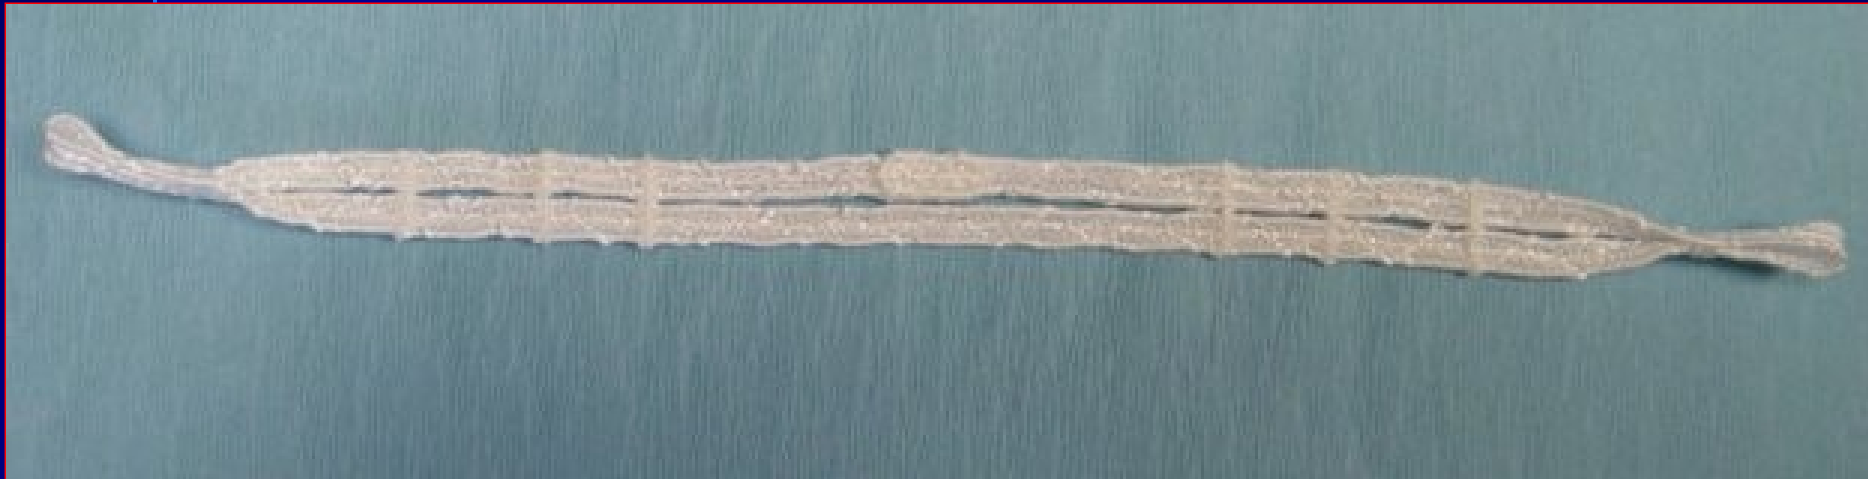
# The Button Hole Soffix (Soft Tissue Fixation Device) Mark II

Various Lengths: 15.5 cm, 17.0 cm and 18.5 cm

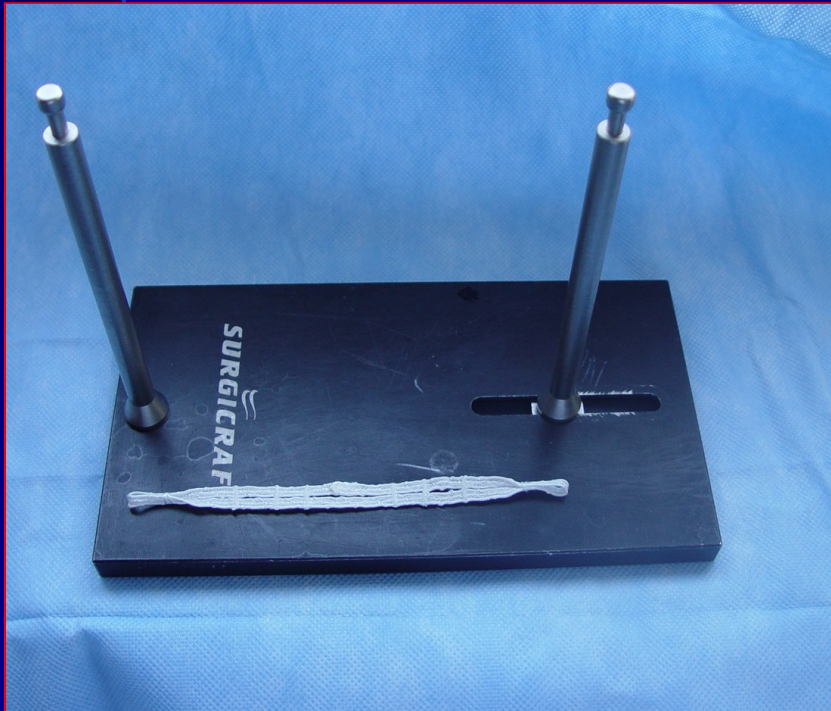
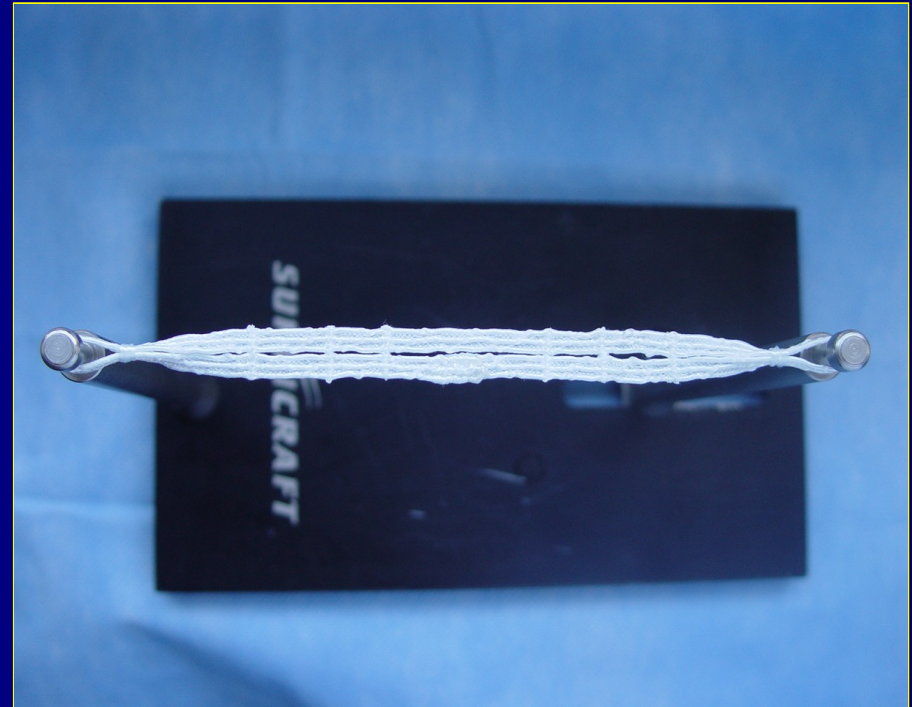
Soffix Mounted on Adjustable Frame

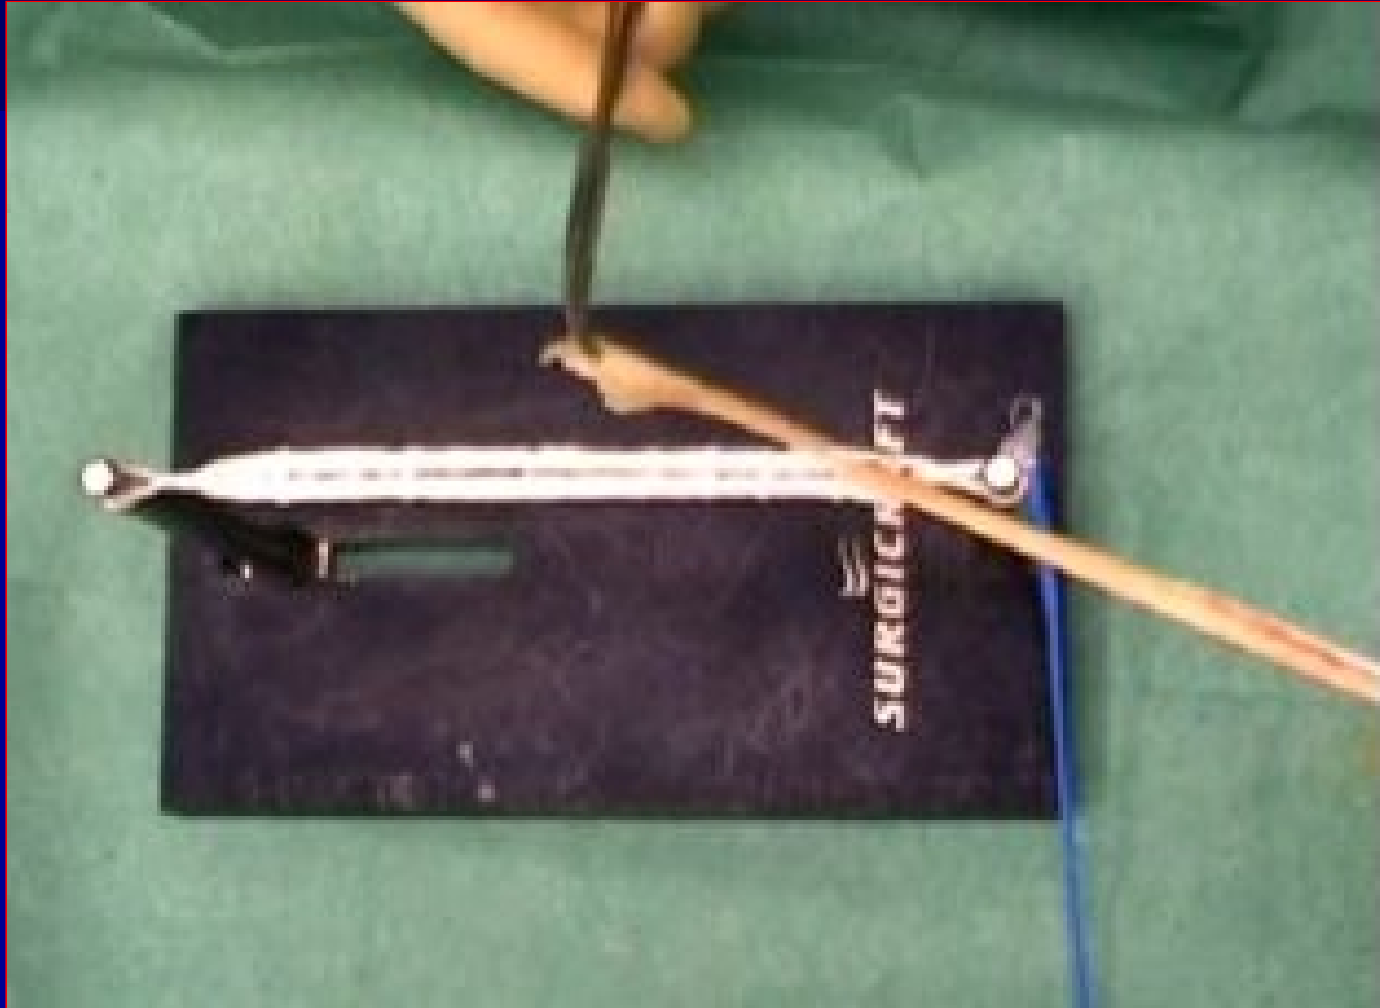
4 Strand STG-Soffix Complex on Frame  
Following Graft Preparation

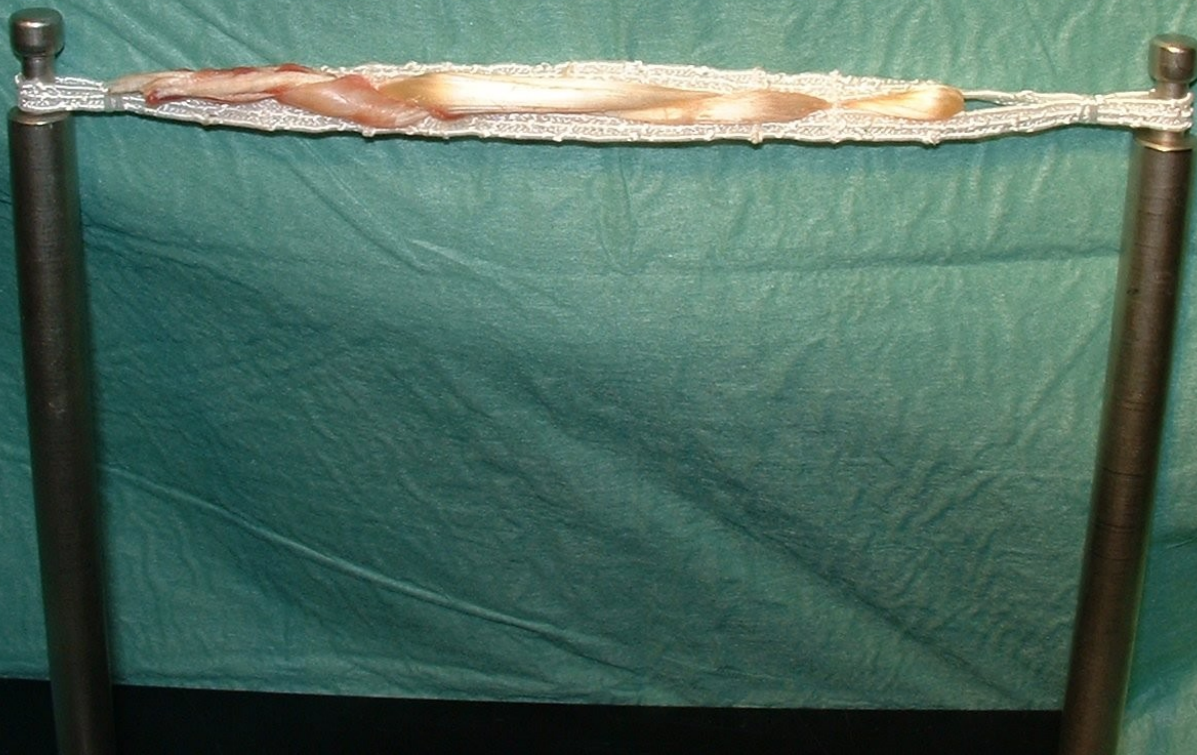
## 4 Strand STG-Soffix Complex on Frame Suturing of the Four Strands

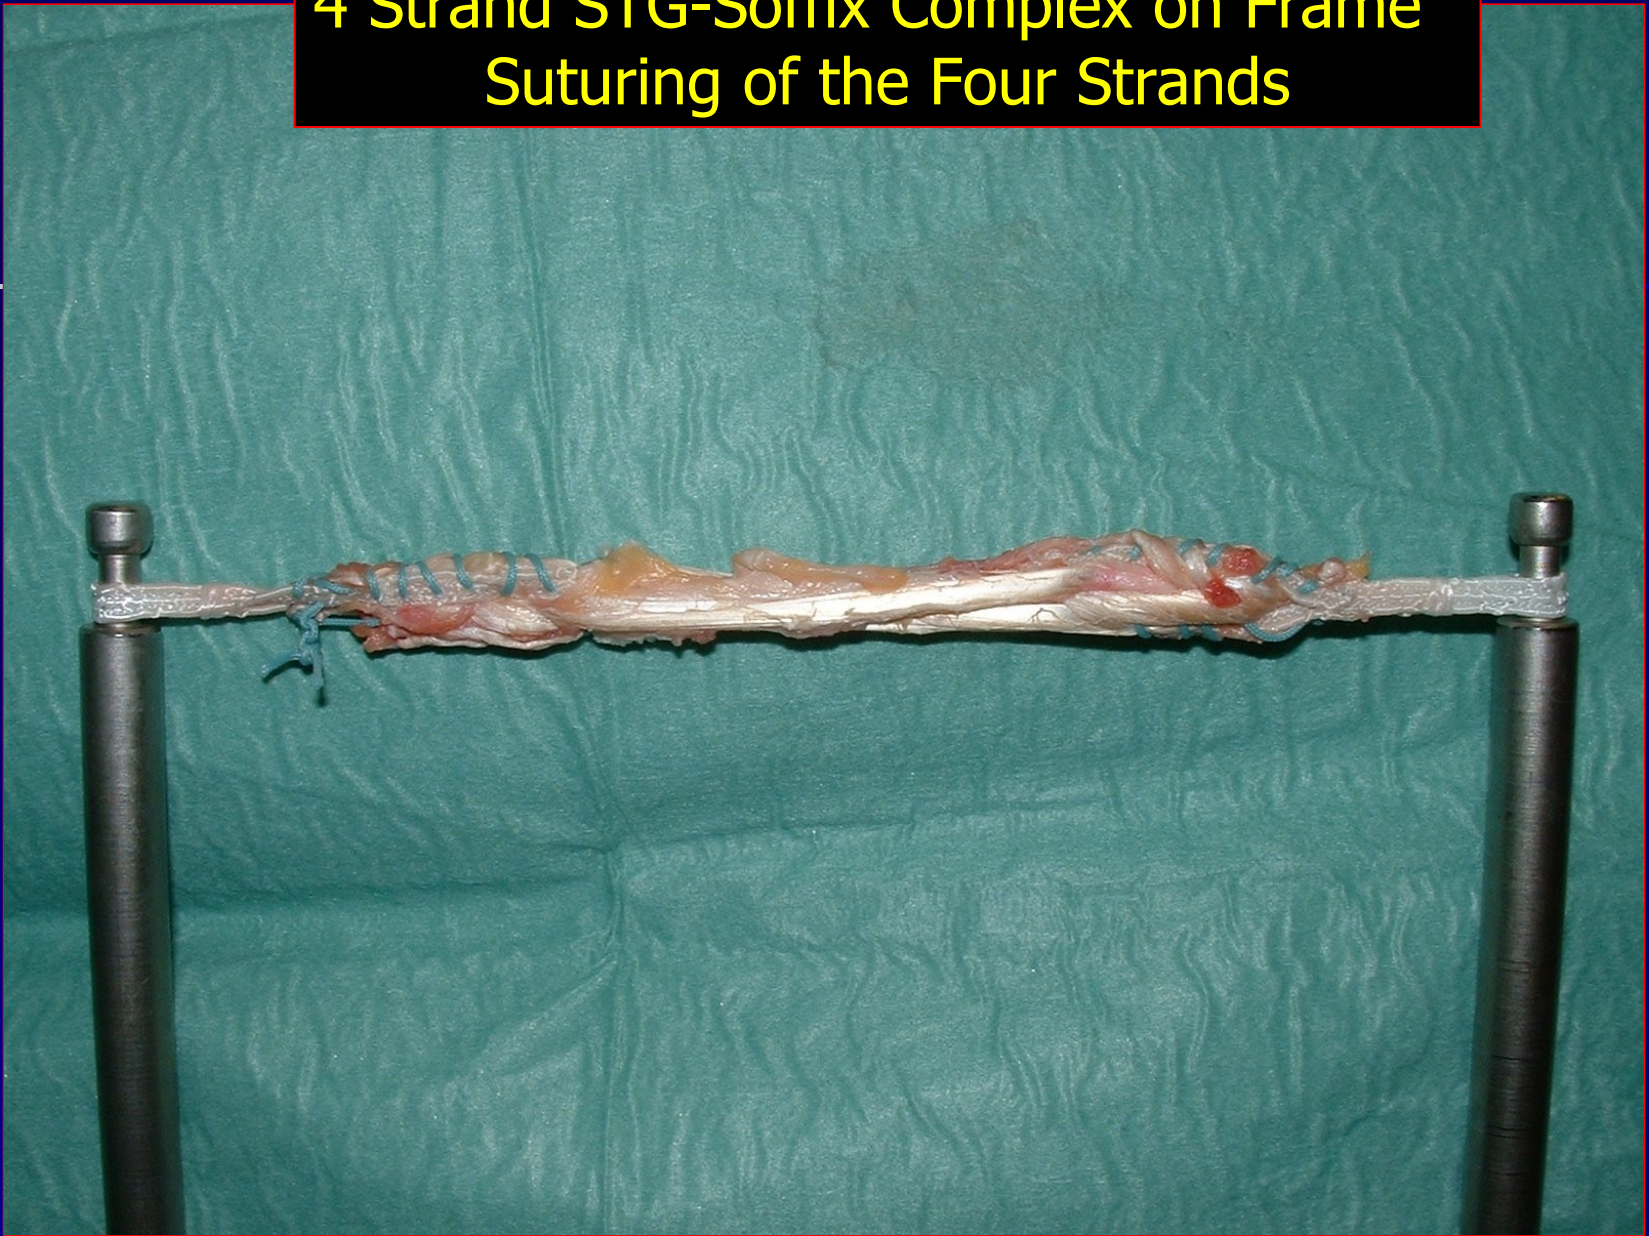
The central 4 – 6 cm of Soffix tape is excised prior to implantation

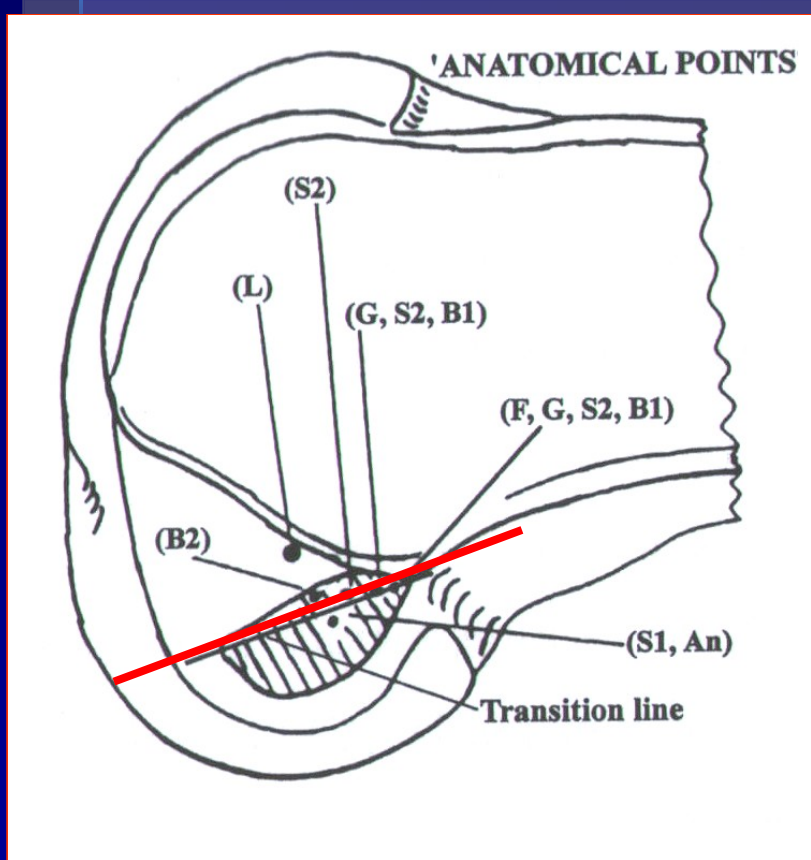
A study using navigationally guided probes to determine ideal femoral siting established the transition line.

- The Transition Line (Amis + Zavras)
- Placing all the graft fibres posterior to the transition line ensures that it is tight in extension and slackens in flexion
- Placing the graft over the top ensures this.
